# Safety & Occ. Health Program

**Great Lakes and Ohio River Division**

# **FY 03 Contractor Accident Experience**

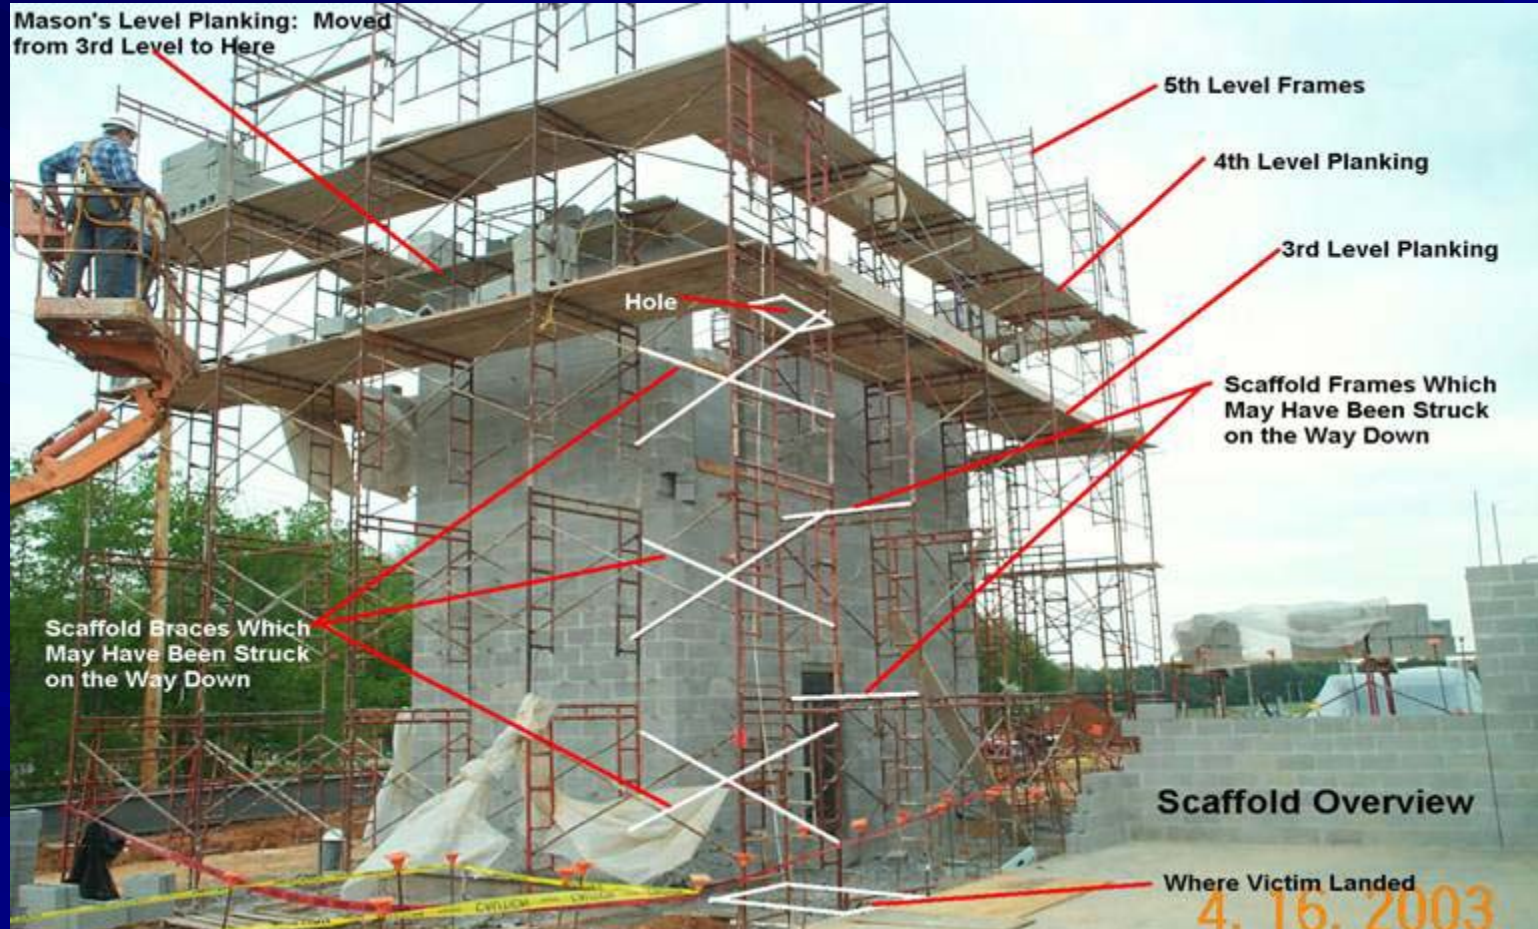
# Scaffold Accident

- Failure to use fall protective equipment.
- Failure to follow hazard analysis
- Failure to provide training on scaffolding
- Inadequate supply of scaffold materials.
- Work schedule rushed.
- Unseasoned supervision.
- Inspections/reports general and not specific to type/location of scaffold.

- Ensure use of fall protection.
- Training on fall protection and scaffolding.
- Work performed under the direction of competent person.
- Strict adherence to hazard analysis.
- Prior to each day's use the scaffold should be inspected, assured safe and inspection documented.

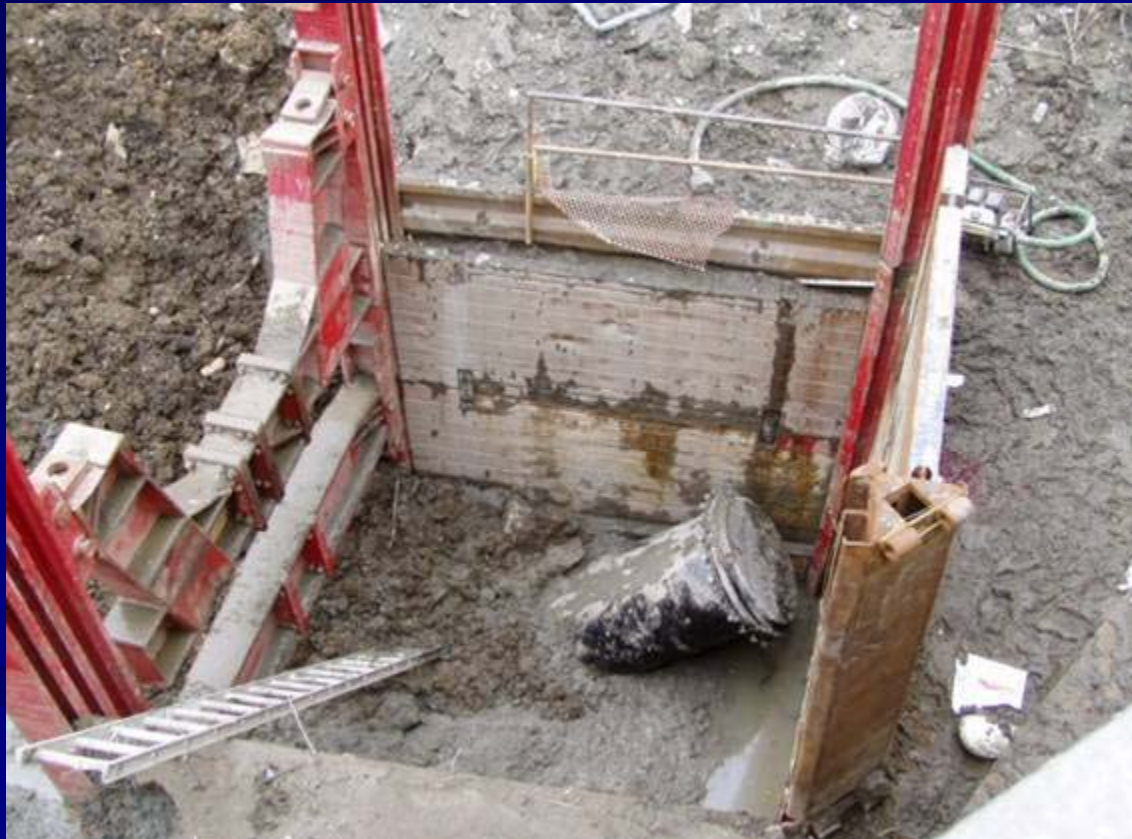
# Accident Scene

## Shoring System In-place

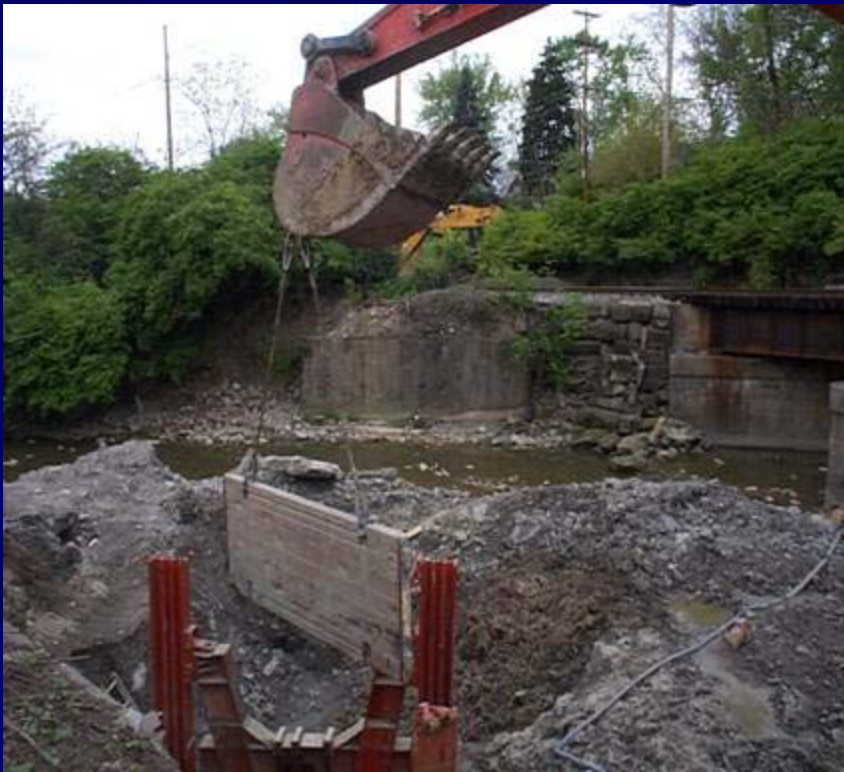
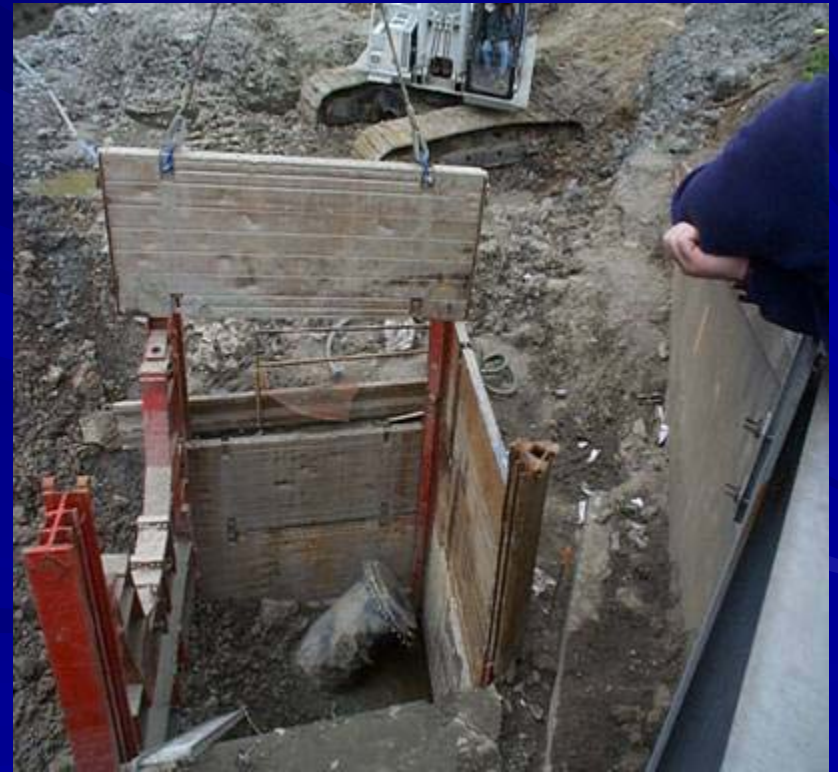
## Causes of Accident

**Direct Cause: Improper Lifting Technique**

- Lack of safe clearance.
- Wet/congested work area.
- Inadequate AHA & insufficient review.
- Difficulties installing and removing shoring system in the type soil is inherent with the shoring system.

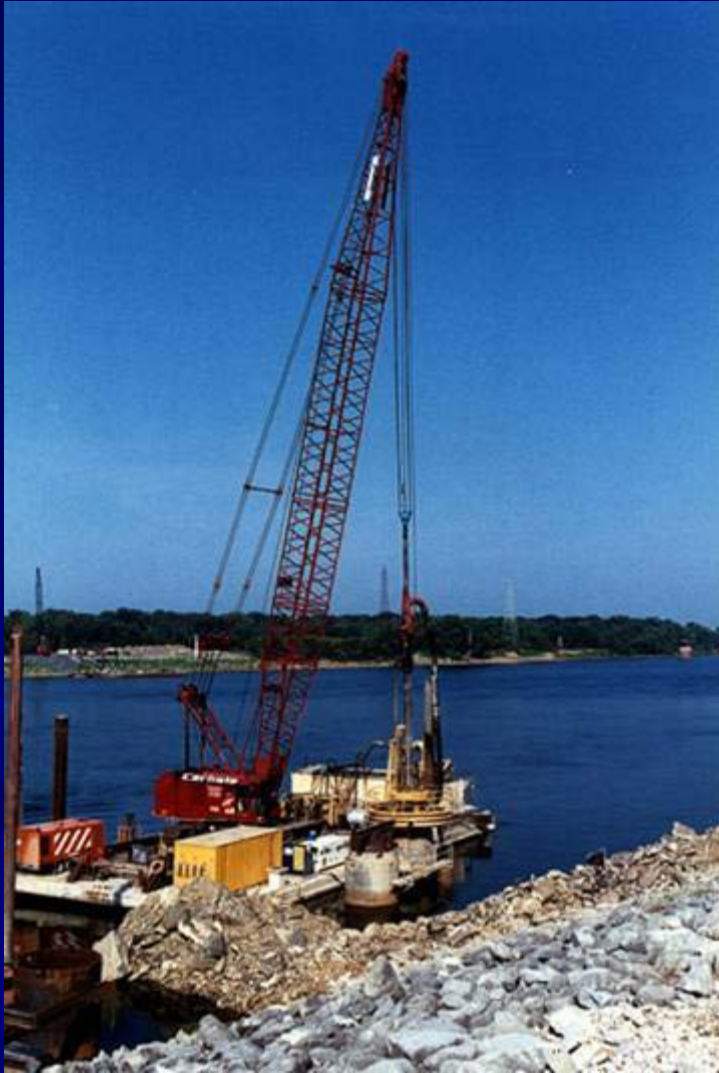
# Crane Accident

- Original procedure was to use 2 cranes to empty the drilling spoil material.
- Due to proximity of river bank, only 1 crane could be used.
- Lift attempted & Crane overturned

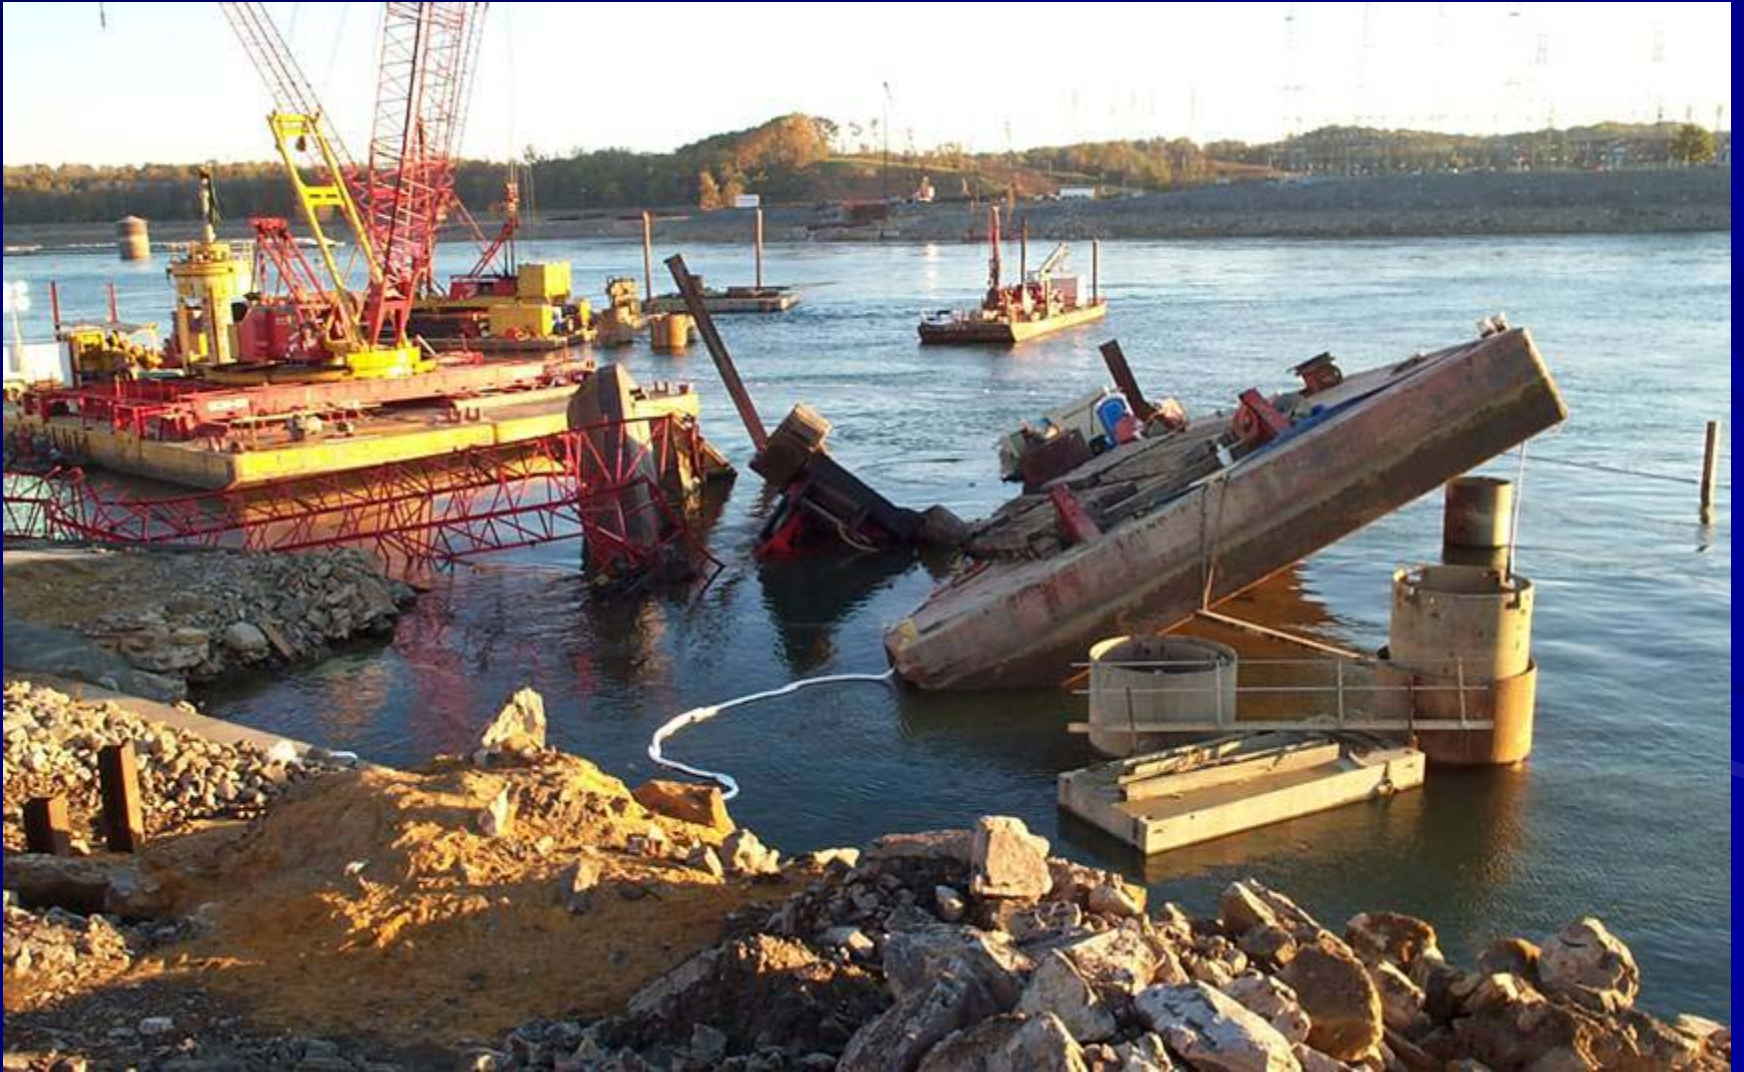
# Outcome

- Exceeded load limits of crane.
- Changed lift procedures without approval of resident engineer
- Load charts were misapplied
- Lifting procedures were not adequately addressed in hazard analysis.

- Modify hazard analysis to adequately address lifting procedures.
- Reinforce significant procedural changes must be approved by Resident Engineer.
- Require refresher training for operators, riggers, & supervisors
- Require magnetic angle indicator for determining list.
